**Subject: Removal Site Evaluation Report
St. Joe Trailer Court Site, Viburnum, Iron County, Missouri
U.S. EPA Region 7 START 4, Contract No. EP-S7-13-06, Task Order No. 0191
Task Monitor: Megan Schuette, On-Scene Coordinator**

**REMOVAL SITE EVALUATION REPORT
ST. JOE TRAILER COURT SITE
VIBURNUM, IRON COUNTY, MISSOURI
EPA ID MON000703744**

**Superfund Technical Assessment and Response Team (START) 4
Contract No. EP-S7-13-06, Task Order No. 0191**

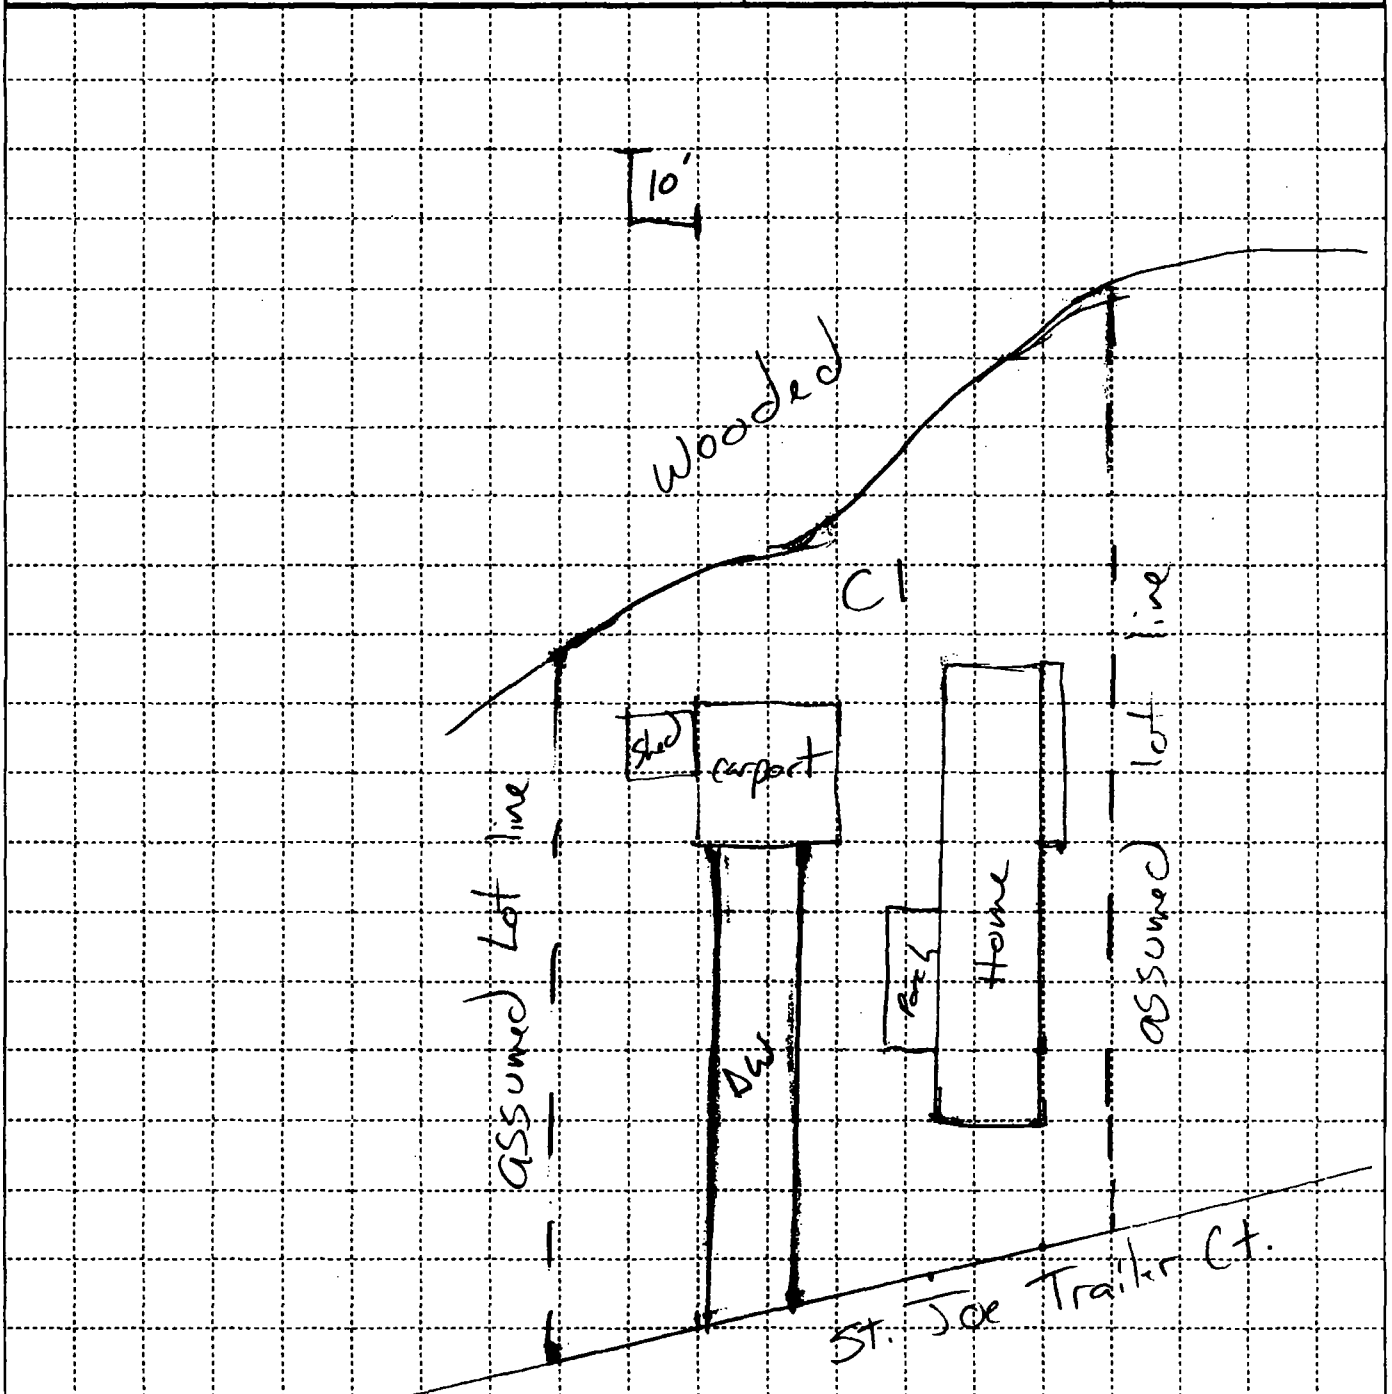
Property ID: SJTCL09

Pre Post NA
Cell 1: 313
Cell 2:
Cell 3:
Cell 4:
Cell 5:

Pre Post NA
DW 1: 255
DW 2:
Garden:
Play Area:
Landscape:

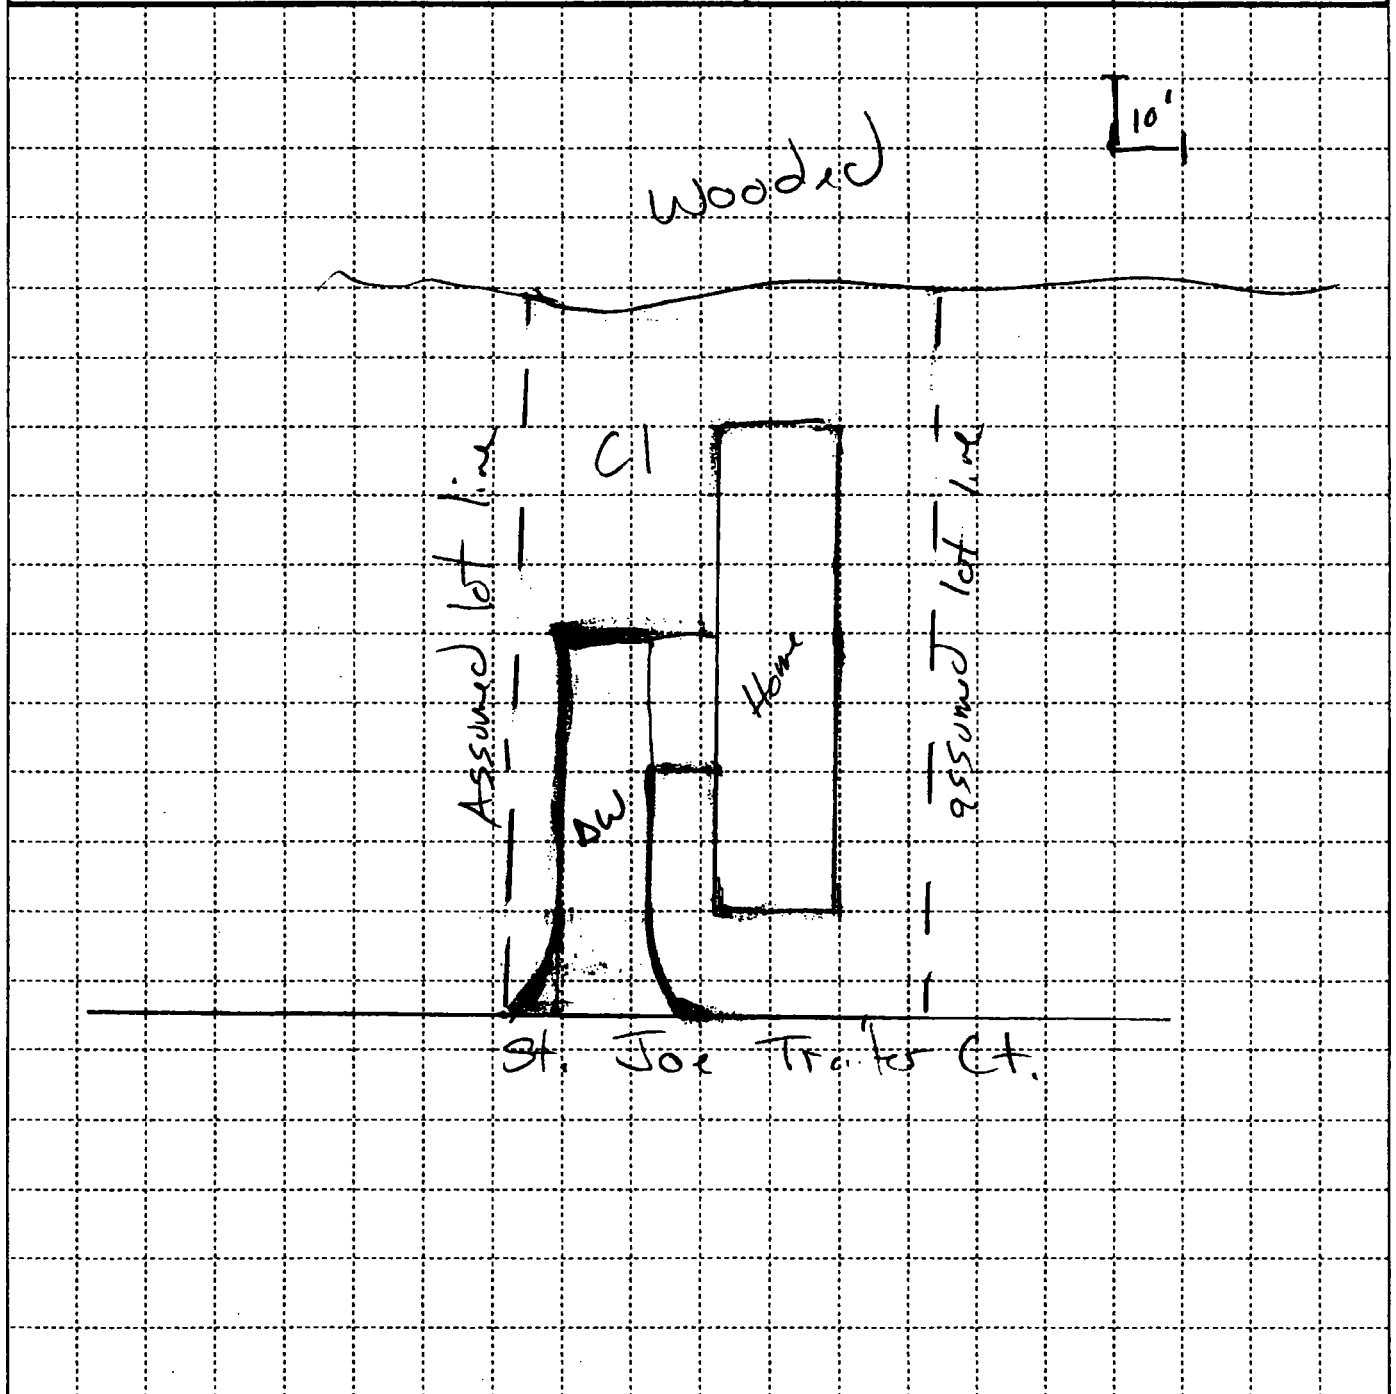
Property ID: SJTC 11

Cell 1: Pre 274 Post NA
Cell 2: _____
Cell 3: _____
Cell 4: _____
Cell 5: _____

DW 1: Pre 53 Post NA
DW 2: _____
Garden: _____
Play Area: _____
Landscape: _____

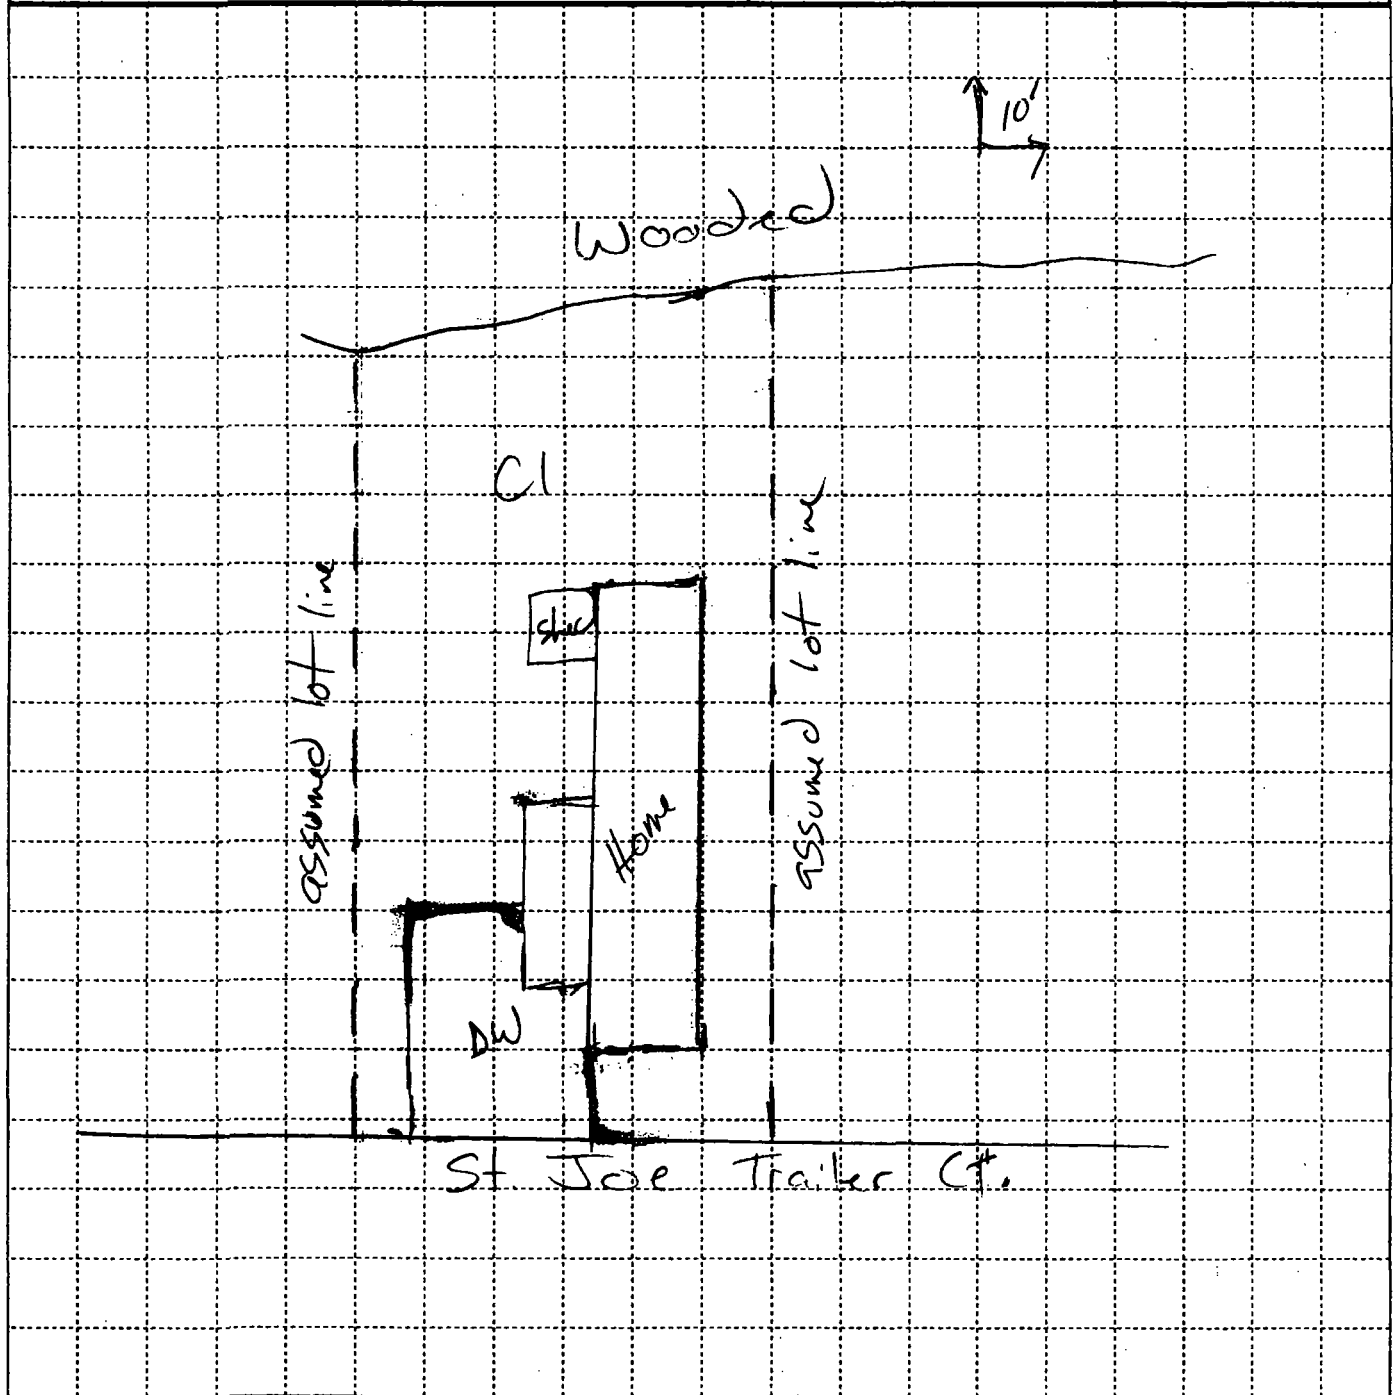
Property ID: SJTC 33

Pre	Post
Cell 1:	<u>116</u>	<u>NA</u>
Cell 2:		
Cell 3:		
Cell 4:		
Cell 5:

Pre	Post
DW 1:	<u>454</u>	<u>NA</u>
DW 2:	<u>487</u>	
Garden:		
Play Area:		
Landscape:

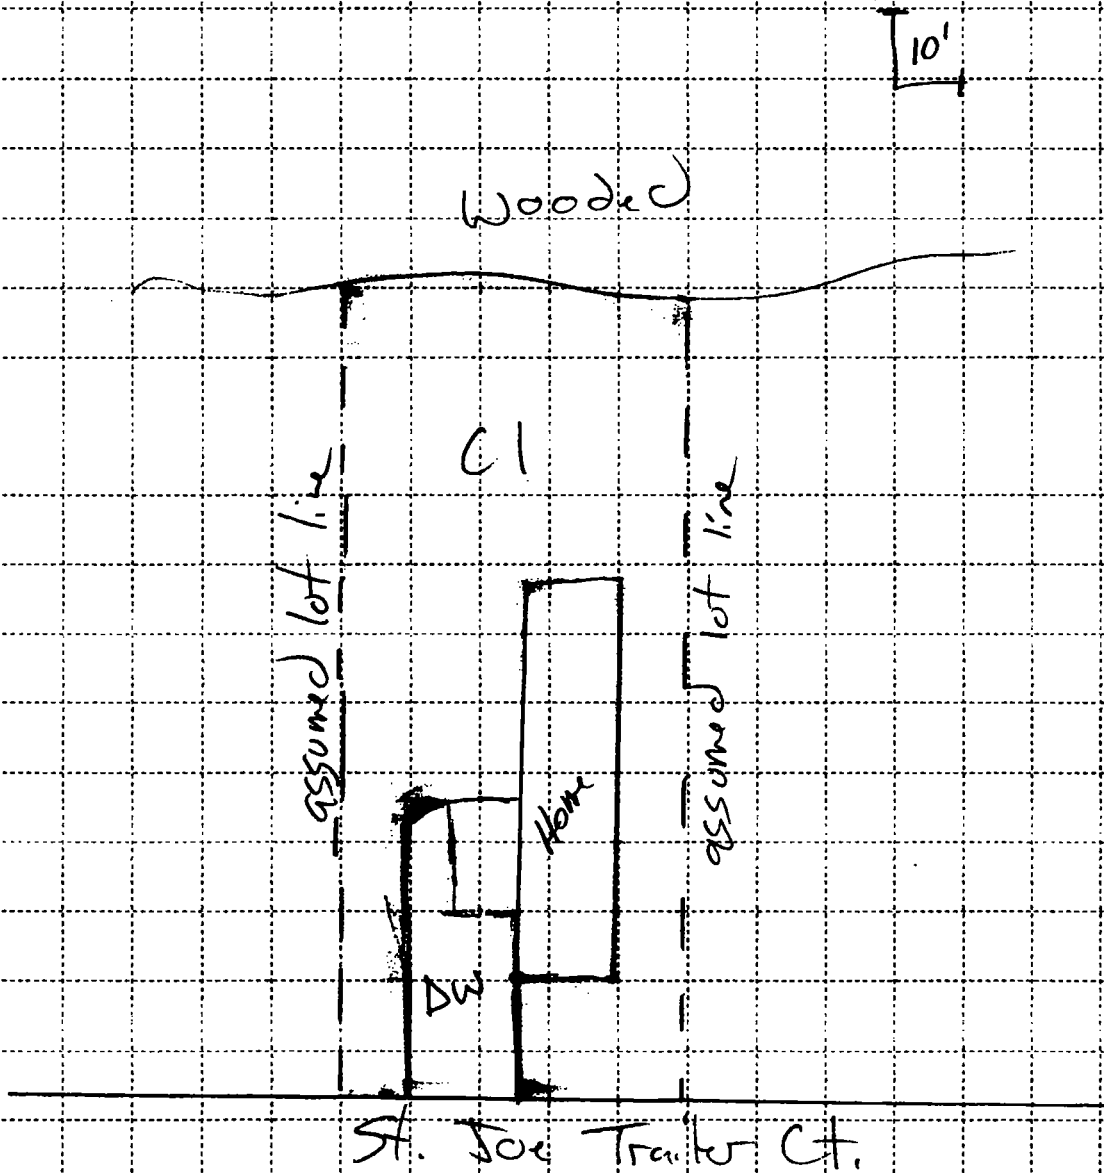
Property ID: SJTC35

Cell 1: Pre 181 Post NA
Cell 2: _____
Cell 3: _____
Cell 4: _____
Cell 5: _____

DW 1: Pre 602 Post NA
DW 2: _____
Garden: _____
Play Area: _____
Landscape: _____
